National Dam Inspection Program.  
Moraine State Park Dam (NDI PA-273),  
Ohio River Basin, Muddy Creek, Butler  
County, Pennsylvania. Phase I Inspection  
Report.

PHASE I REPORT  
National Dam Inspection Program

Moraine State Park Dam

1 and 5 September 1978

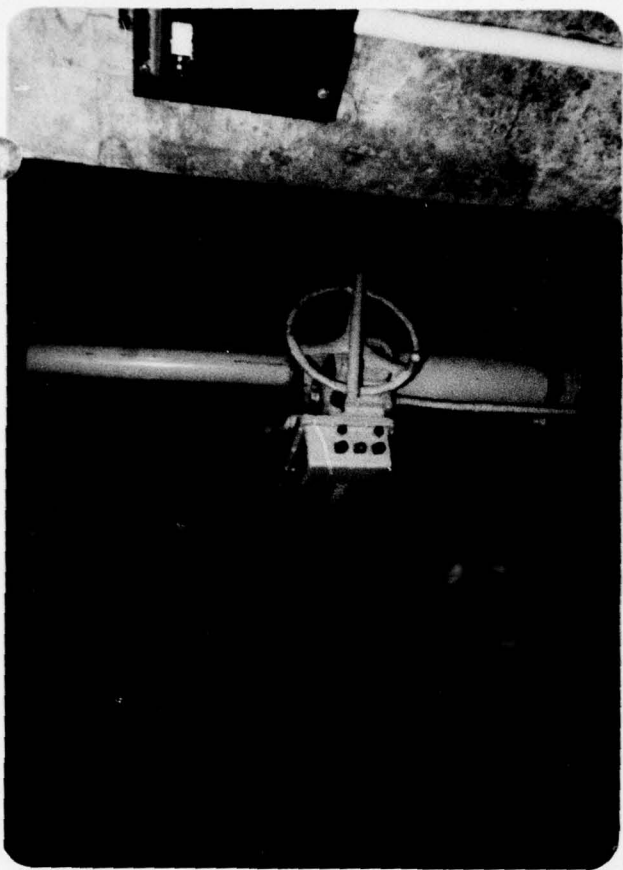
10

The Operating Room, sluice gate, and bypass control appear to be in excellent condition (Photograph 10).

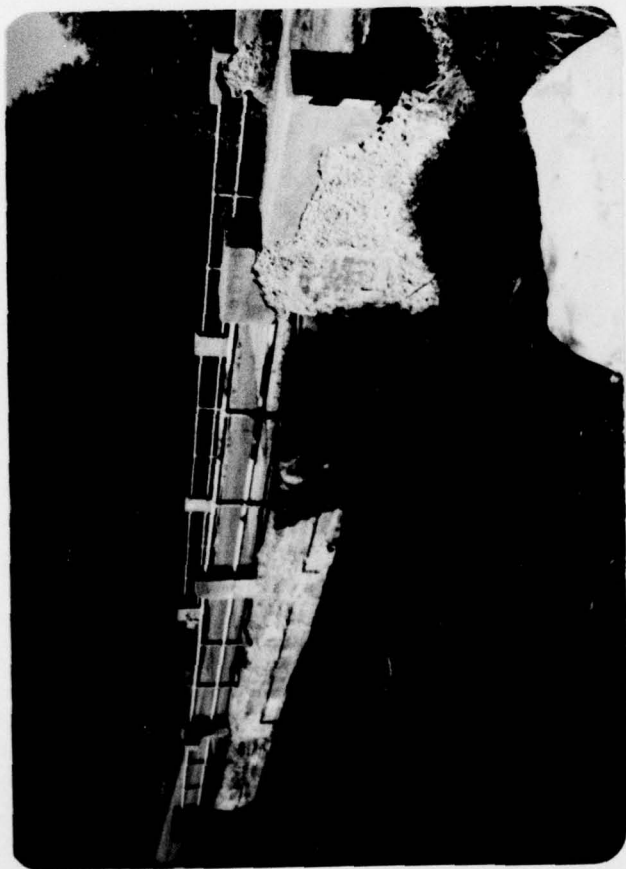
PHOTOGRAPH 13 The bridge in this view is the first stream obstruction located approximately 2,000 feet downstream of the spillway.
